**WESTMORLAND SHOPPING CENTRE CAR PARK
KENDAL**

**REPAIR SPECIFICATION
&
BILL OF QUANTITIES**

Project: Westmorland Shopping Centre Car Park, Kendal
Project Number: K37544
Project Description: Repair Specification & Bill of Quantities

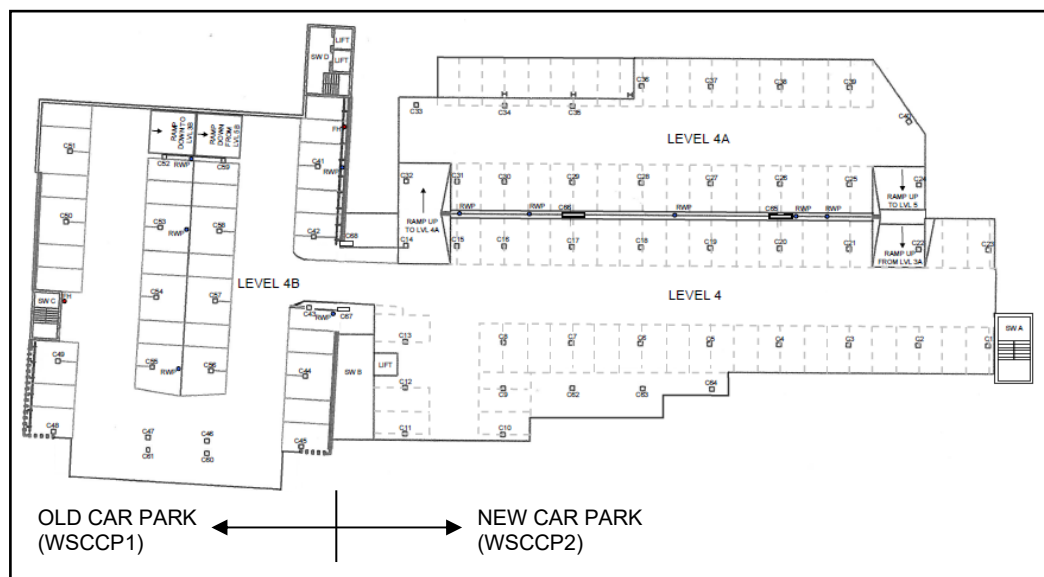
Figure 1.2 Typical car park layout (Level 4 shown)

The car park comprises two separate adjoining structures as indicated in Figure 1.2. The older car park structure, located to the south, comprises 7 no. storeys and was constructed during the 1960's. For ease of reference the older car park structure will be referred to as WSCCP1, and each of the level numbers will be followed by the suffix "B" (except for Levels 6 & 7). There are no historical records or construction drawings available for this structure but it has been confirmed that the structure is primarily of a reinforced concrete lift-slab construction with areas of cast in-situ concrete slab along the edges and along the boundary with the shopping centre. The original external cladding generally comprises precast concrete balustrade units, edge panels, quoins and fin units.

The original car park construction was later extended, modified and refurbished during the 1990's. The newer car park structure, located to the north, comprises 5 no. storeys of split level. For ease of reference the newer car park structure will be referred to as WSCCP2, with the upper split level number followed by the suffix "A", and the lower split level number without a suffix. There is limited information available for this structure but construction drawings indicate the structure to be a post-tensioned reinforced concrete lift-slab on reinforced concrete columns. Cladding is formed principally by blockwork walls built off the floor slabs with an external render applied. A slate mansard canopy roof feature forms the roof to the car park at Level 5 and 5A in the new car park and Level 7 in the old car park.

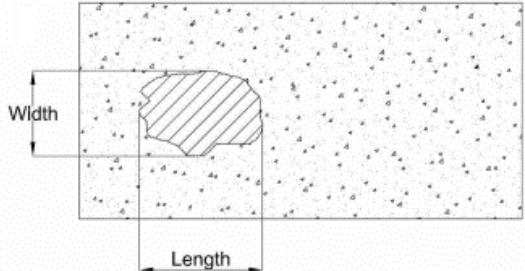
Defect Type	Description	Diagram
1	Vertical Surface, no arrises

<p>Fig 1.</p> <p>Area = Length x Width</p> <p>Depth of repair = maximum depth of the repair within a substantial proportion of the repair area.</p>
2	Soffit Surface	As Fig. 1
3	Deck Surface	As Fig. 1
4	Two Vertical surfaces, one arris (e.g. column)

- a) In general, repairs on flat surfaces do not include for the re-creation of an arris the repair shall be measured by area and depth in accordance with Fig. 1.

- d) Repairs to flat surfaces which include an arris and which lie outside the maximum girth of 400mm shall also be measured as two repairs. The arris repair shall be taken as 400mm girth as Fig. 2 and the other repair shall be measured as a repair to a flat surface of the remaining area as Fig. 1.

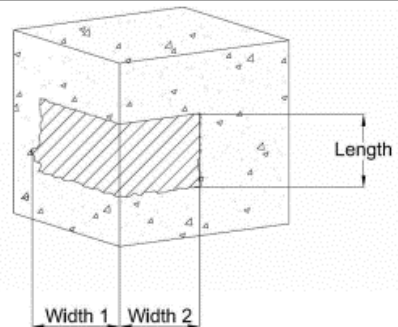
<p>Fig 2.</p> <p>Length is longest length measurement Width measurements should be taken on a left to right basis.</p> <p>Where the area of damage includes a soffit this is recorded as width 1.</p> <p>Girth = Width 1 + Width 2</p> <p>Depth of repair = maximum depth of the repair within a substantial proportion of the repair area.</p>
5	Two Horizontal surfaces one arris including a soffit (e.g. beam or slab edge)	As Fig. 2

- b) If a repair to a beam, column or slab edge includes one arris and the girth is <400mm it shall be measured in accordance with Fig. 2.
- c) If a repair to a beam, column or slab edge includes two arrises and the girth is <800mm it shall be measured in accordance with Figs. 3.1 and 3.2.

- e) A similar approach shall be adopted if the repair covers two arrises and the girth of the repair is >800mm. The repair would be measured as three separate repairs; two single arris repairs with a girth of 400mm as Fig 2. with the central flat surface measured as Fig. 1.

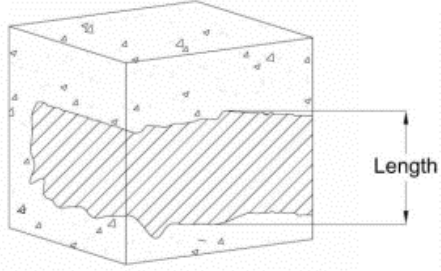
<p>Fig 3.1</p>

<p>6</p>	<p>Three Vertical surfaces, two arrises (e.g. column)</p>

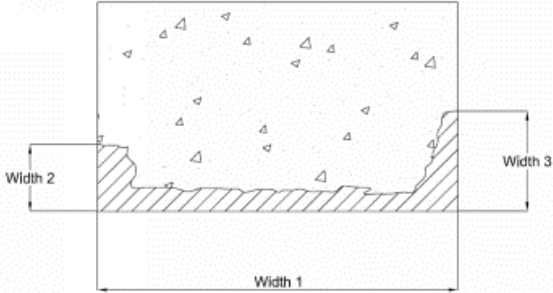
<p>Fig. 3.2 When an area of damage has two arrises and three planes the central plane width dimension should be recorded as width 1. Remaining width dimensions should be taken on a left to right basis. $Girth = Width\ 1 + Width\ 2 + Width\ 3$</p> <p>Depth of repair = maximum depth of the repair within a substantial proportion of the repair area.</p>
<p>7</p>	<p>Three horizontal surfaces, two arrises one soffit (e.g. Beam)</p>	<p>As Fig 3.1 & 3.2</p>
<p>8</p>	<p>Slab corner repairs</p>

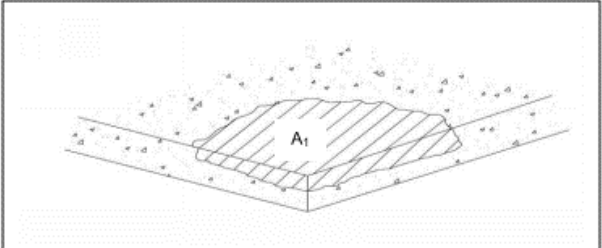
<p>Fig 4. Repairs on slab extending along two edges, measured as one repair A_1</p>

- f) An exception to this is repairs to corners of slabs or balconies and the like. Repairs measured in this category include for the re-creation of three arrises e.g. two horizontal and one vertical meeting as a common point. In this case the area shall be measured as the sum of the areas on the individual faces and recorded as a specific item see Fig 4.

depth of a repair. For repair to corners of slabs of balconies and the like, as in fig. 4, where repairs span more than one face of a member, the depth (including the specified depth of concrete removal from behind bar) shall be measured on the largest face and this depth used to categorise the repair.

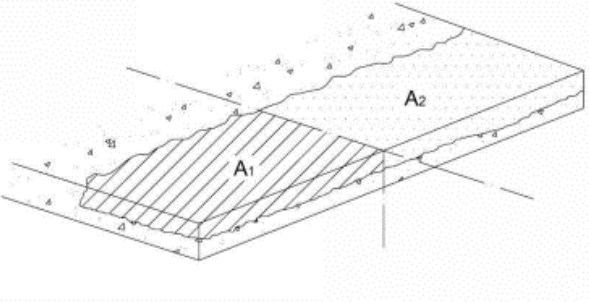
9	Repairs on slab extending along three edges

<p>Fig. 5 Repairs on slab extending along three edges, measured as two repairs – one of area A1, and one of area A2.</p>
---	---	--

- g) Repairs including two corners of a slab or balcony and the like involving five arrises shall be measured as two repairs with the centre line of the slab taken as the dividing line between repairs and recorded as a separate item as Fig 5.
