Management and Safety of Memorials Policy

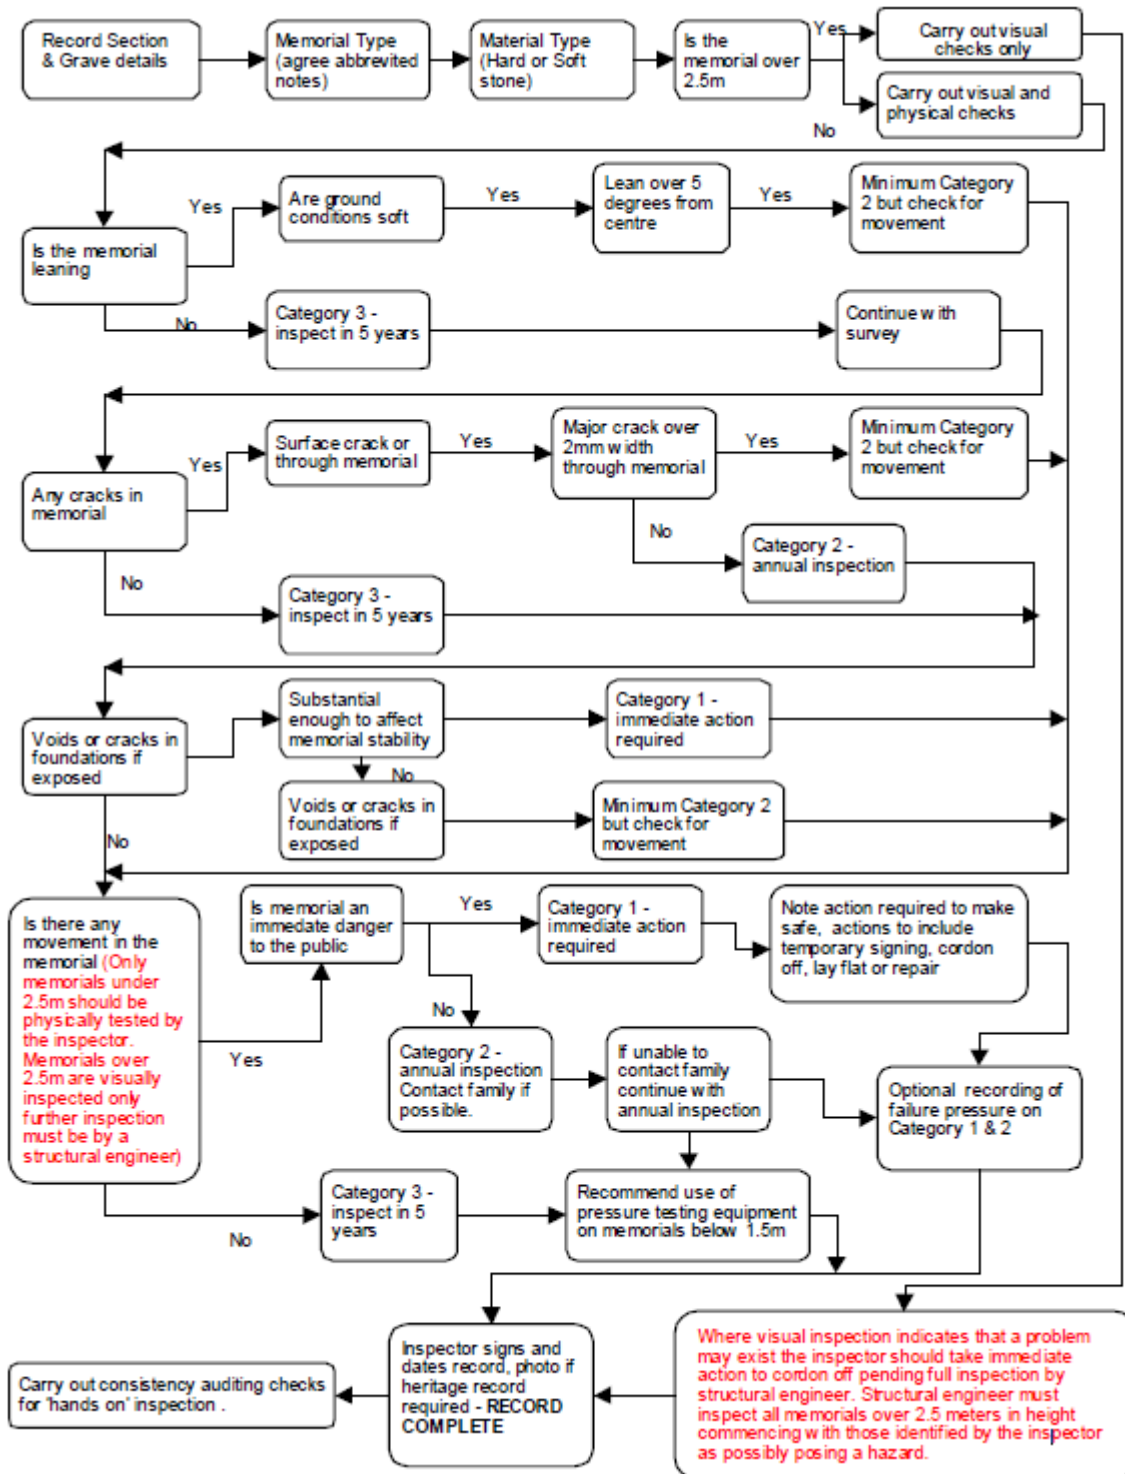
Appendix 3.0 – Inspection Flowchart

The flow chart as Appendix 3.0 explains the inspection regime and indicates factors which place memorials in various categories.

Should there be movement detected prior to the maximum test pressure being reached, the operative must cease testing. Where this movement could result in the sudden failure of the memorial it will be deemed unstable and immediate action must be taken. This action will be explained in the flow chart section to follow.
